2013 UTSR Gas Turbine Industrial Fellowship Program

Gas Only IPI Braze Failure

Samuel Gates
sgates5@uwyo.edu
University of Wyoming
Mechanical Engineering

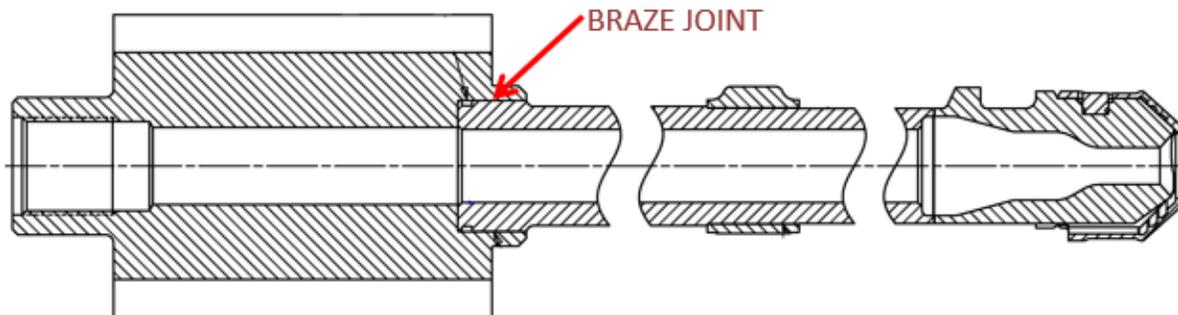
Figure 1: Gas Only IPI Braze Joint Failure

This part contains multiple weld and braze connections. However, the joint in question is the connection interface between the nickel-plated 321 SS flange and the Hastelloy X oil tube, as is designated by the red arrow in Figure 1. Figure 1 also illustrates the location of the vacant groove where the braze filler material will reside prior to the brazing process.

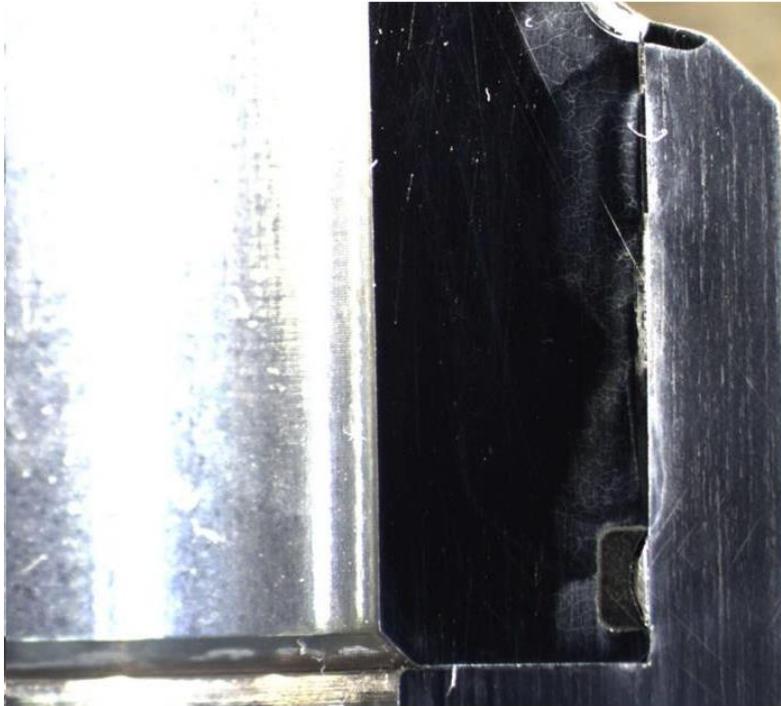
Figure 2. Post-braze visual inspection failure

Due to the geometry of the joint, it is expected that the majority of the braze filler material would exhibit capillary action towards the atomizer tip. The filler material should be visible to the naked eye after a successful braze joint. However, this was not the case for about 20% of the parts that have undergone the process. The filler material for these parts was not succumbing to the capillary process leaving noticeable voids for the visual inspection. Figure 2 helps illustrate this issue.

This specific part underwent post braze corrective actions by being additionally braze from the external surface (top in Figure 2). However, if one looks closely they can see the extent of the capillary action from the original brazing process, which only extended about halfway. Another large issue from the braze joint is a lack of wetting to either the Hastelloy X tube or the nickel plated 321 stainless steel flange. The gold braze material appeared to not wet at all to the flange, and it appeared to only partially wet to the tube. This is also evident in Figure 3.

The large amount of braze material remaining in the braze groove is additionally indicative of the lack of capillary action and wetting present in this specific braze. Both Figure 2 and Figure 3 show this. Ideally, this groove should be entirely evacuated indicating that all of the filler material is used and that the interface has its optimal strength.

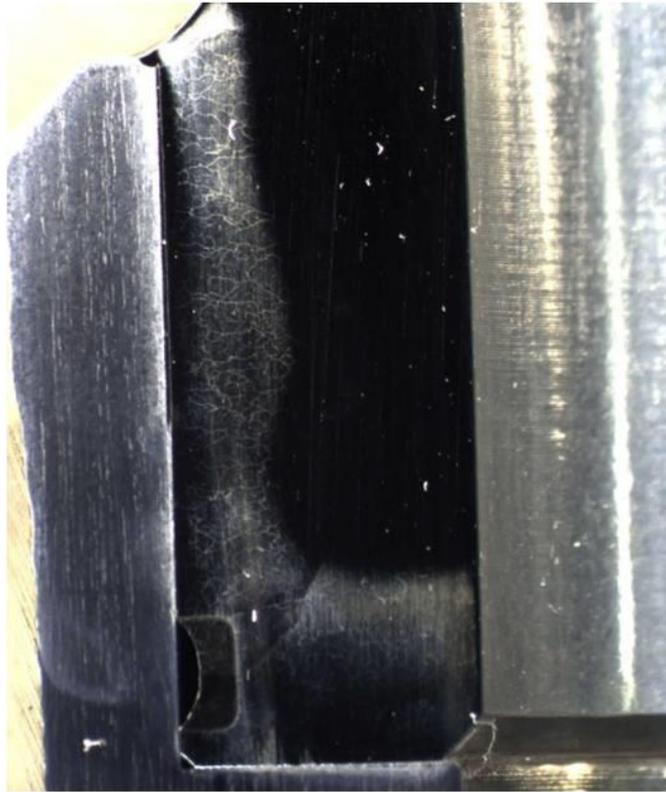
Figure 3. GO IPI braze failure joint

One can see that the material only wetted a few millimeters into the Hastelloy X tube, and didn't wet at all to the external 321SS flange. Figure 4 shows a relatively clean surface of the flange braze surface. Clearly, the braze material did not wet nor adhere to this surface.

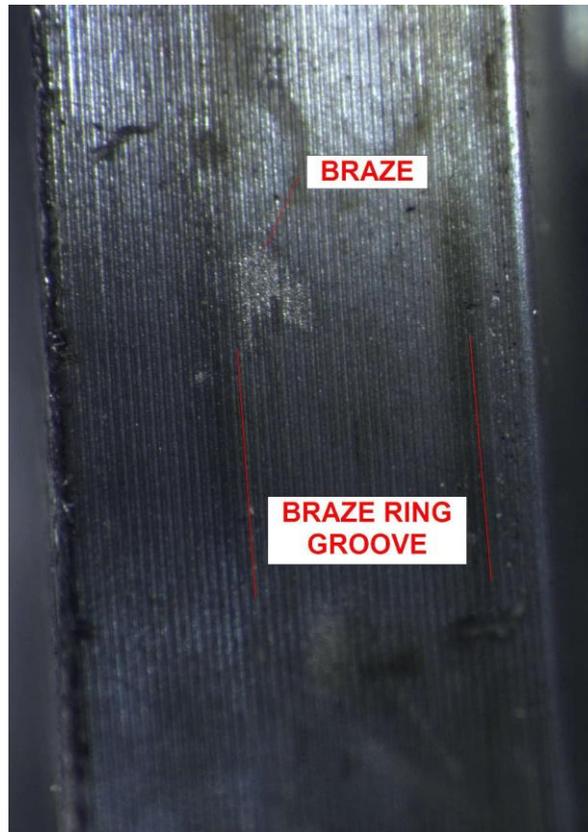
Figure 4. Flange braze surface

It is also possible that the surface finish of the nickel plating is too smooth, which would limit the capillary effects of the braze material. However, this is unlikely considering the surface structure illustrated in Figure 4. One can see the machined grooves on that surface, which should facilitate the viscous flow of the filler material.

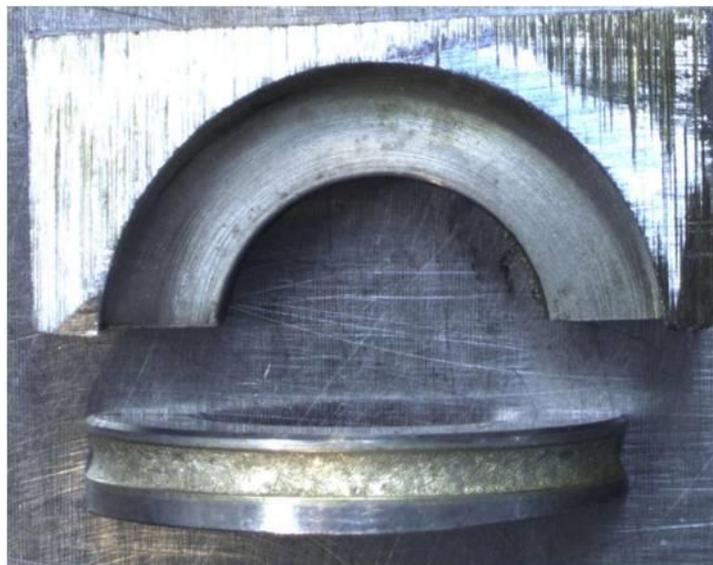
Figure 7. Failed braze material

It was suggested to test the material using a scanning electron microprobe analysis through an external company, Lucideon Laboratories. The SEM process would be able to accurately measure the material composition at a focused location. The excess material residing the groove ring could be prepared for testing with SEM microprobe. The bottom part in Figure 7 shows the residual material to be tested.

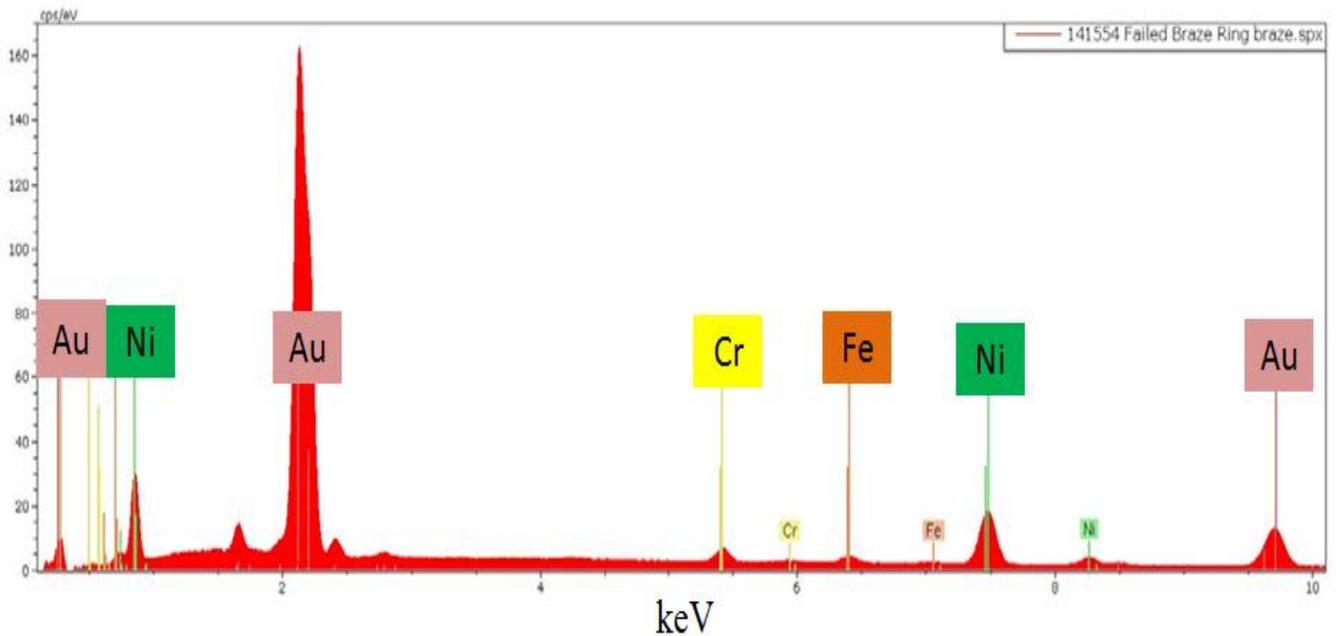
Figure 9. Material energy spectrum measured using microprobe

Figure 9 shows the existing spectral lines present in this specific sample.

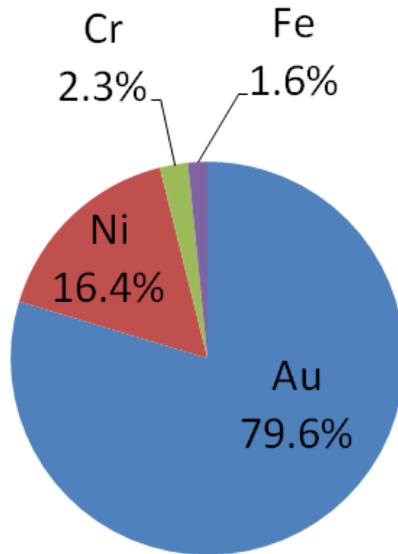
Figure 10. Material composition by weight

When comparing these results to the AMS standard (Figure 6), it is clear that these results don't entirely obey specified chemical compositions; there are significant amounts of chromium and iron and a diminished quantity of nickel. However, it is important to note that the braze material had partially wetted with the Hastelloy-X tube, which contains significant compositions of chromium and iron explaining this discrepancy. See Figure 11.
