2013 UTSR Gas Turbine Industrial Fellowship Program

Gas Only IPI Braze Failure

Samuel Gates
sgates5@uwyo.edu
University of Wyoming
Mechanical Engineering

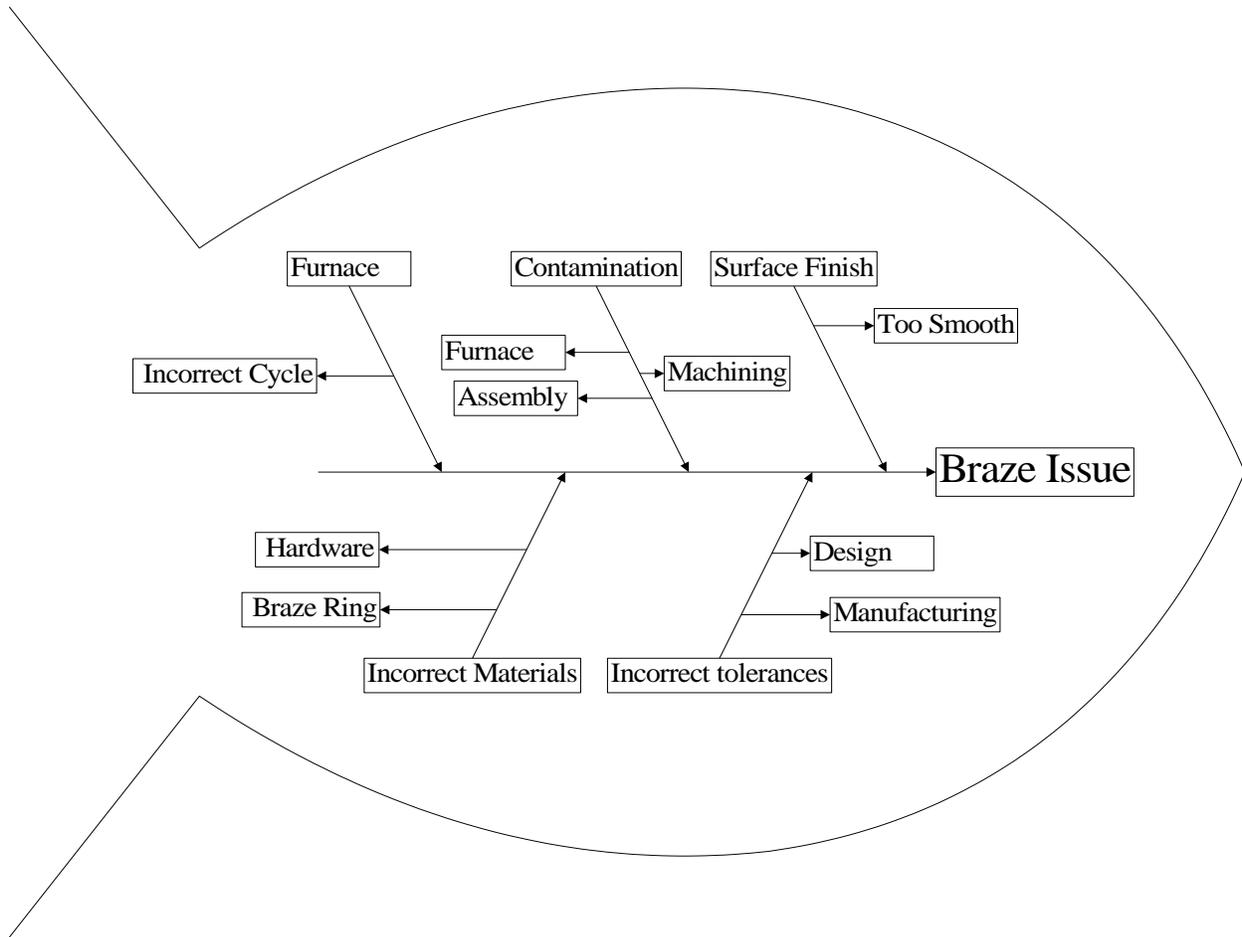
Figure 5. Braze failure fishbone guide (Narasimhan & Jones)

In order to curb the undesirably high dropout rate of this braze joint, it is important to understand the root cause of why these joints are failing. A systematic approach to investigating the joint can be taken by adhering the following guide (Figure 5) to braze joint failures.

Some of the potential causes can be ruled out by ensuring the braze process parameters are correct: heat temperatures, soak time, filler material volume, and braze joint tolerances. However, the other parts of the investigation are a bit more in depth.

It is possible that the samples that had failed were exposed to contamination prior to brazing. Certain contaminants might affect the brazing process in different ways. If, for example, any amount of excess sulfur (lubricant, hand creams, etc.) present in the braze joint, it may cause an embrittlement of the nickel plating on the flange (Schusteritsch & Kaxiras, 2012). If this were the case, it would dramatically alter the brazing chemistry and could require much different soak temperatures, soak times, or other parameters. This however would be very difficult to test for, but could be ensure that the proper cleaning techniques prior to brazing are adhered to in a rigorous manner.

It is also possible that the surface finish of the nickel plating is too smooth, which would limit the capillary effects of the braze material. However, this is unlikely considering the surface structure illustrated in Figure 4. One can see the machined grooves on that surface, which should facilitate the viscous flow of the filler material.

Finally, it is possible that the material composition of the braze rings were not correct. The material may have violated the existing material specification, or braze rings may have been mixed up. In either case, it is important to determine that the materials used in the braze process were correct before any more in depth and rigorous investigation is undertaken.

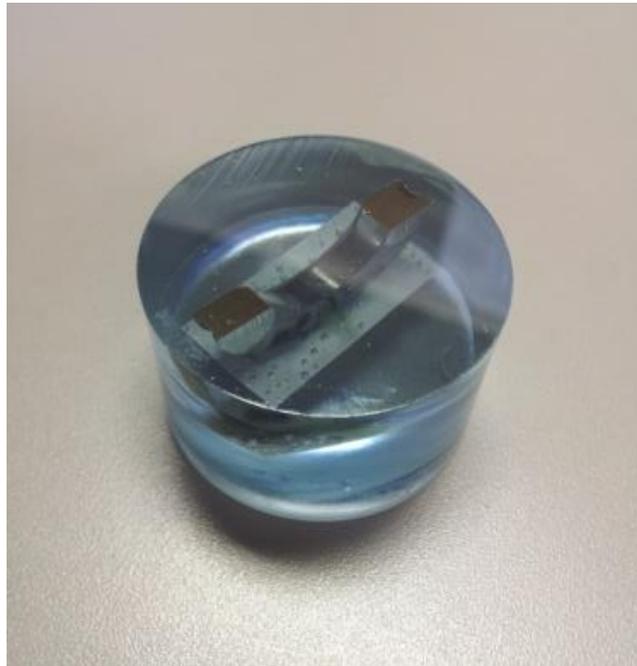
Figure 8. Polished and mounted post braze material

The part was mounted in an epoxy substrate and polished as shown in Figure 8.

Once mounted, the sample was tested using the electron microprobe which also utilizes energy dispersive x-ray spectroscopy.

After testing the un-brazed rings and the post-braze material, it was determined that no errors were made on the part of the supplier nor the braze joint assembly technicians. The braze joints were prepped to specification. This indicates that the explanation of the high drop-out rate is elsewhere in the design of this weld. Further investigation should be undertaken towards other aspects listed in the Figure 5: incorrect tolerances, incorrect braze cycles, or reinvestigate surface finish.

It is recommended that any further braze attempts on this joint should be fully documented: measure each part's actual tube OD, flange ID, and braze material volume. Comparing this information with the success of the weld, one could determine if the tolerances are in fact a driving factor for the failures.
